Meggitt Avionics  
SERVICE INFORMATION  
LETTER No.52 ISSUE 2

HAWKER BEECHCRAFT CORPORATION

SFD MK2 SYSTEM

TROUBLESHOOTING GUIDE

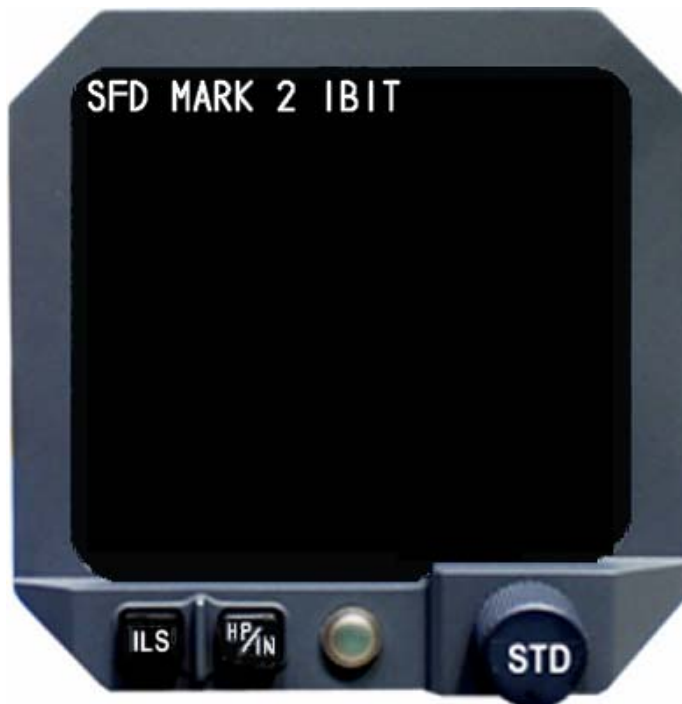
IBIT Page

This page provides an IBIT intro and will display SFD IBIT for 0.5 seconds.

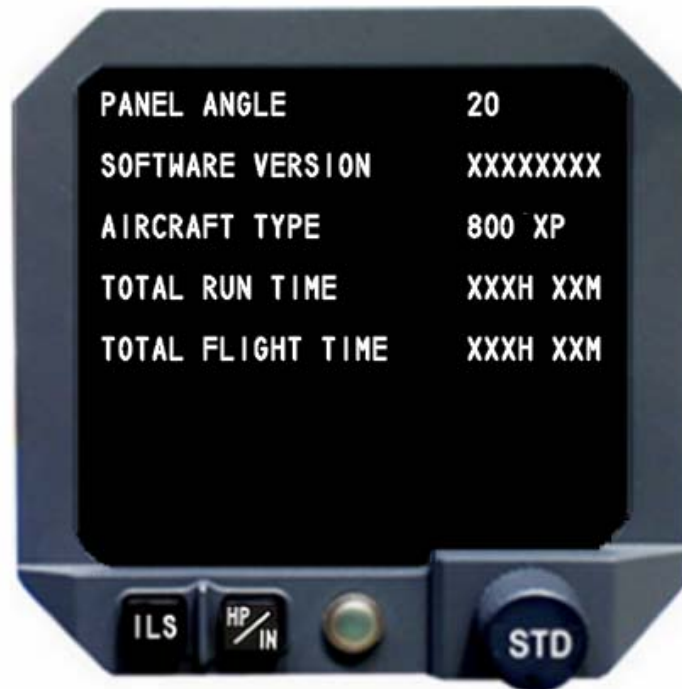
Configuration Page

data x = current aircraft data

This page (displayed for 6 seconds) will display panel angle, software version, aircraft type, total run time, and total flight time data.

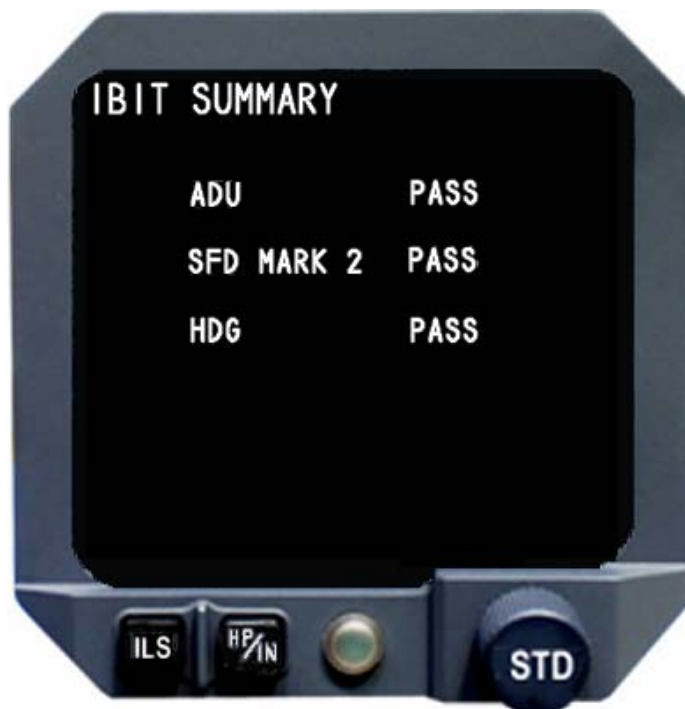
IBIT Summary Page

This page (displayed for 3 seconds) will display unit status and a list of all the ARINC inputs to the unit. It will identify unit status and each input status as PASS/FAIL.

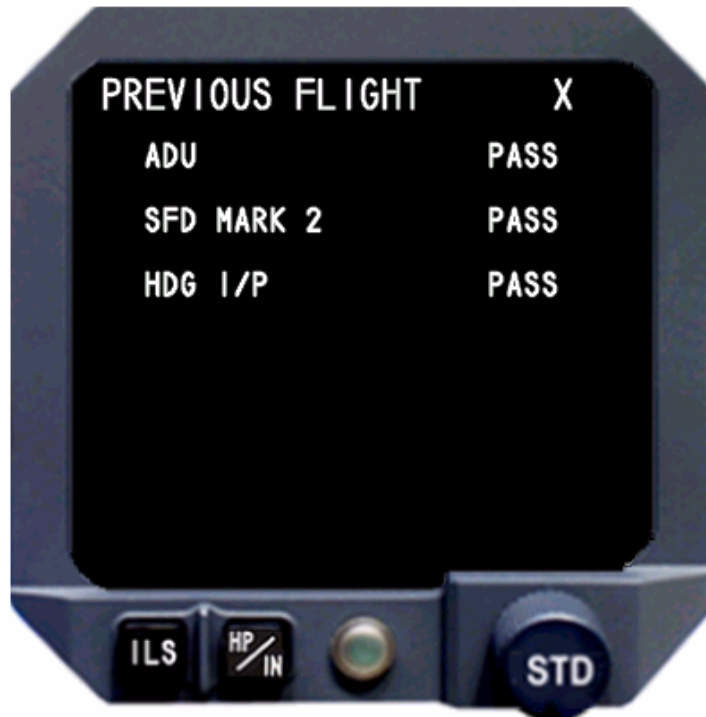
Previous Flight Pages (1 to 8)

Where 'X' can be from 1-8 flight cycles

The unit stores up to 8 flight cycles, which are displayed on each of the eight Previous Flight Pages. Each page is displayed for 3 seconds and displays the same data format as the IBIT Summary Page. The pages are incremented from flight cycles of the SFD™ (Cold start followed by airspeed >100 knots).

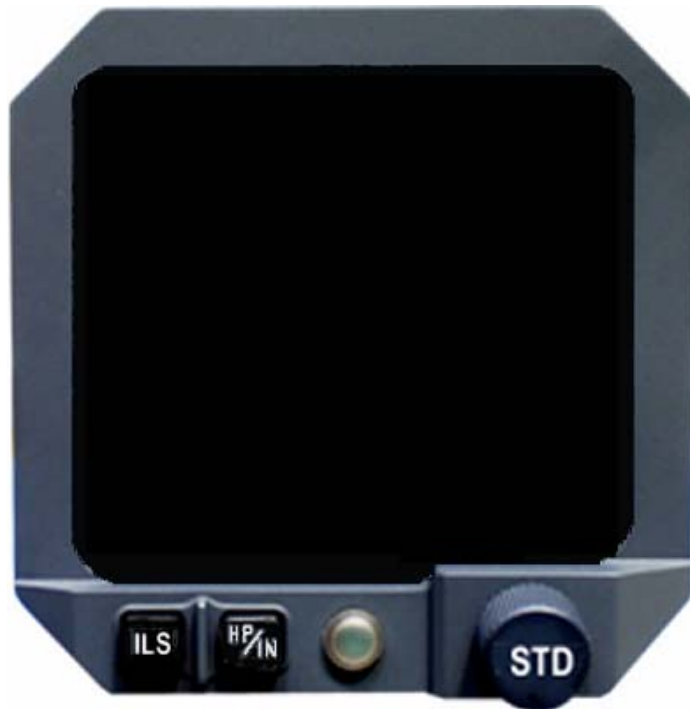
Colour mode Pages

There are six Colour Mode pages. Each page is displayed for 1.5 seconds and displays a solid colour of black, red, grey, blue, green and white in sequence. This figure shows the black colour mode page only).

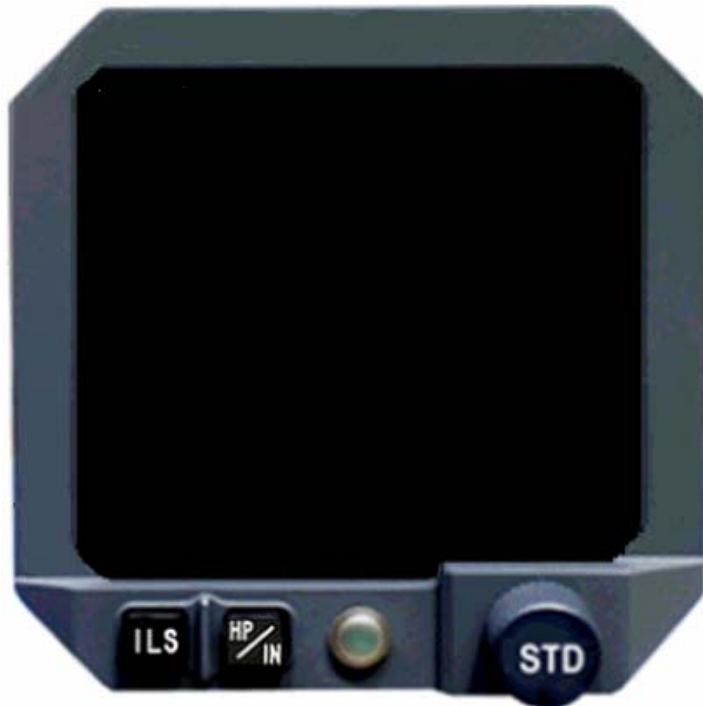
#### Blank Screen

Possible external causes for this include:

- No power to SFD.
- Check Aircraft SFD circuit breaker.
- Check for 28V at pin 4 and 28V return at pin 5.
- The SFD is in Program Mode (Pins 30 AND 33 grounded).

NOTE: The screen will be blank for up to 22 seconds when powering up as the unit performs its BIT checks.

Otherwise, the problem is likely to be with the SFD itself.

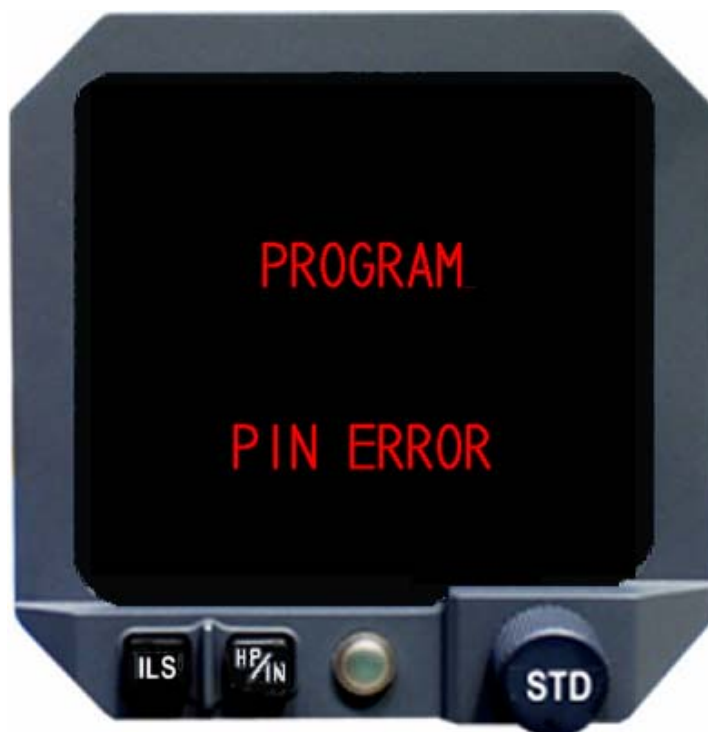
**'PROGRAM PIN ERROR'**

Red text on black background in centre of screen

Possible external causes for this include:

- Aircraft wiring loom fault. Check for short or open circuits at pins 12,13,14,15,17.

**Note, the correct configuration must be checked against the Electronic Standby Instrument System, Wiring Interface drawing.**

Otherwise, the problem is likely to be with the SFD itself.

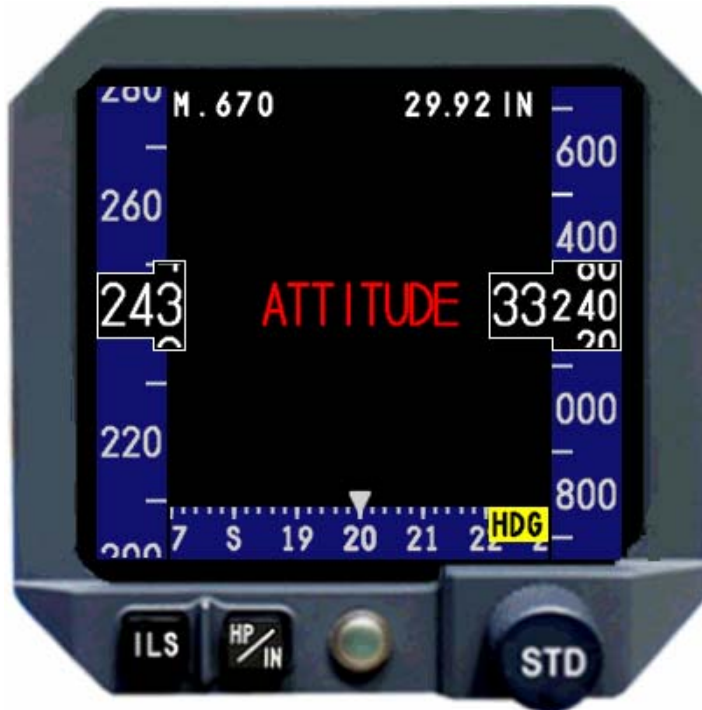
#### 'ATTITUDE'

Red text on black background in centre of screen

Possible external causes for this include:

- Instrument moved excessively, greater than 100deg per second (can occur at any time). Airspeed, altitude and other data can still be displayed.

Otherwise, the problem is likely to be with the SFD itself.

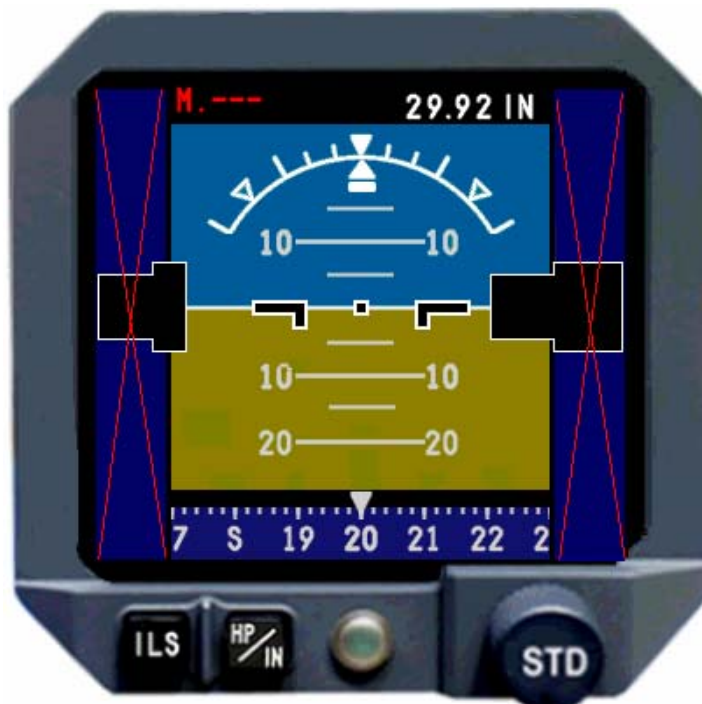
Red Cross replaces altitude tape, altitude digital readout blanked and red cross replaces airspeed tape, airspeed digital readout blanked

Possible external causes for this include:

- Air Data Unit (ADU) not connected.
- Incorrect ADU fitted, a 27101 or 27301 series part number unit is required, not a 27005 series.
- No Power to ADU. Check circuit breaker. Check for 28V at pin N and check 28V return at Pin P.
- Wiring problem with SFD check pins 24 and 25.
- Wiring problem with ADU check pins L and M.
- ADU faulty.
- Perform IBIT and check current status of ADU on third IBIT screen.

Otherwise the problem is likely to be with the SFD itself.

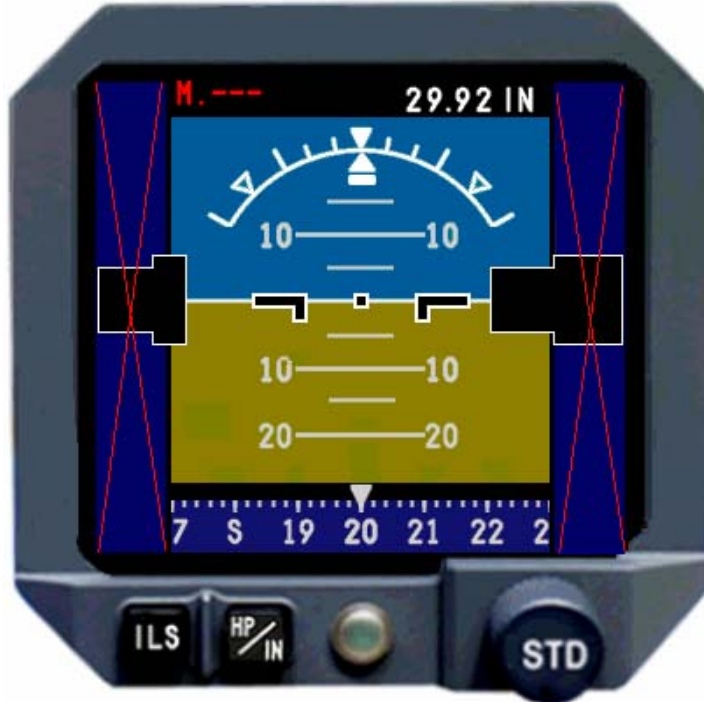
'M.---' in red text in place of Mach reading

Possible external causes for this include:

- Airspeed in excess of 0.999 Mach.
- ADU fault, check whether airspeed and altitude are displayed.

Otherwise the problem is likely to be with the SFD itself.

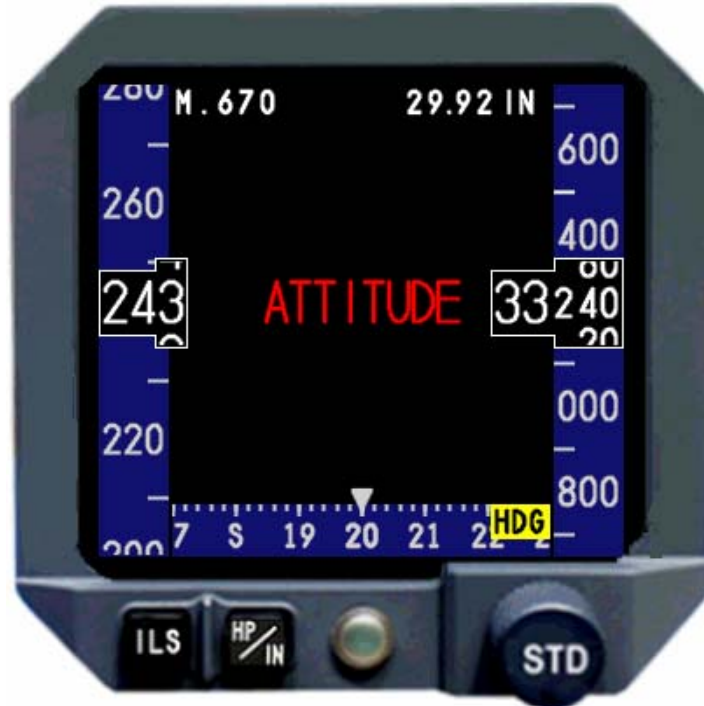
'HDG' in black text on a yellow rectangle within the heading tape

Heading Display is showing non-stabilized magnetic heading input.

Possible external causes for this include:

- Instrument moved excessively, greater than 100deg per second (can occur at any time). Airspeed, altitude and other data can still be displayed.

Otherwise the problem is likely to be with the SFD itself.

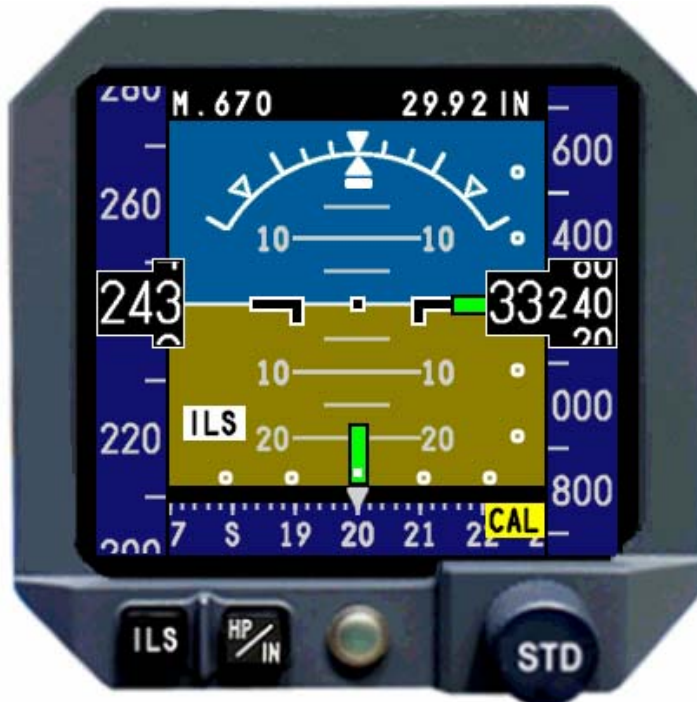
'CAL' in black text on a yellow rectangle within the heading tape

Magnetometer (Heading Input) is in calibration mode. **For Calibration information refer to Annex B**

Possible external causes for this include:

- MHS powered up with Cal switch open circuit. Referring to Electronic Standby Instrument System, Wiring Interface drawing ensure the calibration switch is correctly short circuited at the maintenance panel.
- Wiring to MHS Cal pins is faulty. Check input to pins 7 and 8 on the MHS are short circuit.
- MHS Faulty.

**There is not likely to be a problem with the SFD that can cause this without a heading fail.**

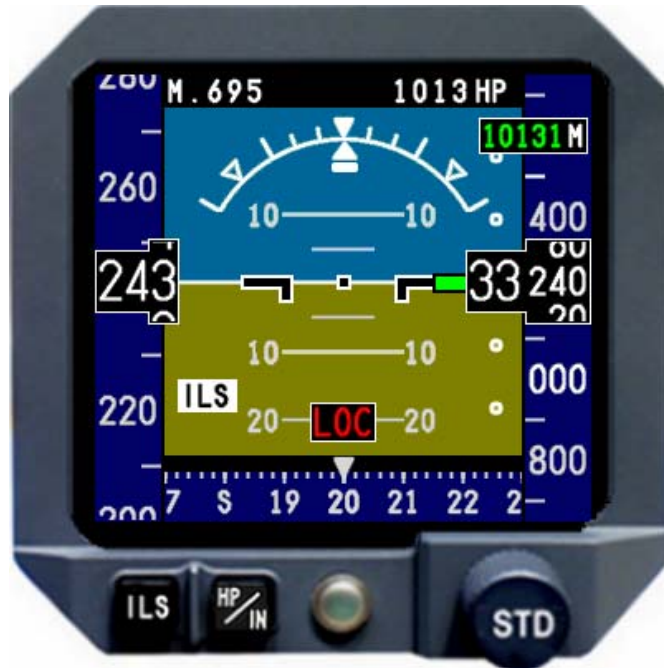
'LOC'

Red text on a black rectangle in a white box

Possible external causes for this include:

- ILS localizer data is not being received. This can be either from a digital (ARINC 429) or analogue source.
- Check circuit breakers for aircraft ILS radio.
- Check operation of ILS Localizer.
- Check Analogue Localizer signals at pins 31 and 32.
- Check Arinc 429 ILS at pins 10 and 11.
- Check Disc\_IN 1 (localizer valid) at pin 3.

Otherwise the problem is likely to be with the SFD itself.

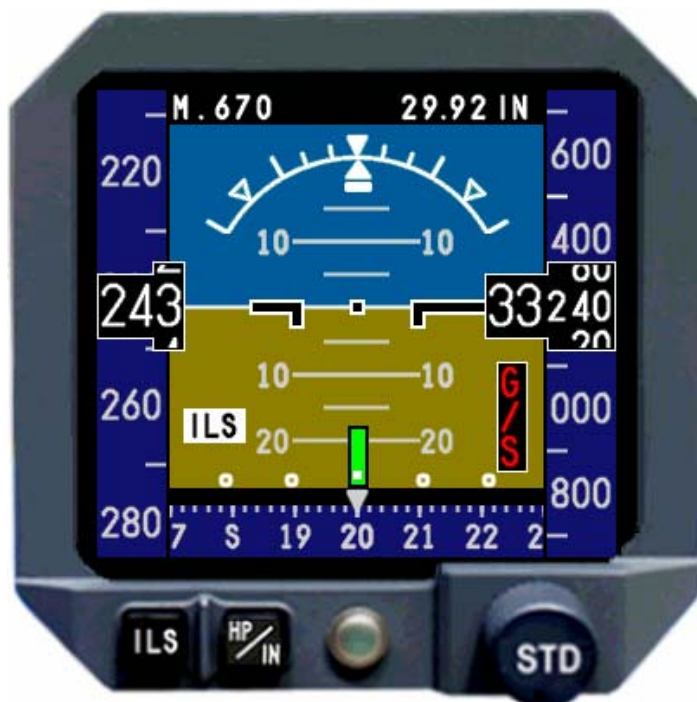
'G/S'

Red text on a black rectangle in a white box

Possible external causes for this include:

- ILS Glideslope data is not being received. This can be either from a digital (ARINC 429) or analogue source.
- Check circuit breakers for aircraft ILS radio.
- Check operation of ILS Glideslope.
- Check Analogue Glideslope signals at pins 8 and 9.
- Check Arinc 429 ILS at pins 10 and 11.
- Check Disc\_IN 2 (Glideslope valid) at pin 18.

Otherwise the problem is likely to be with the SFD itself.

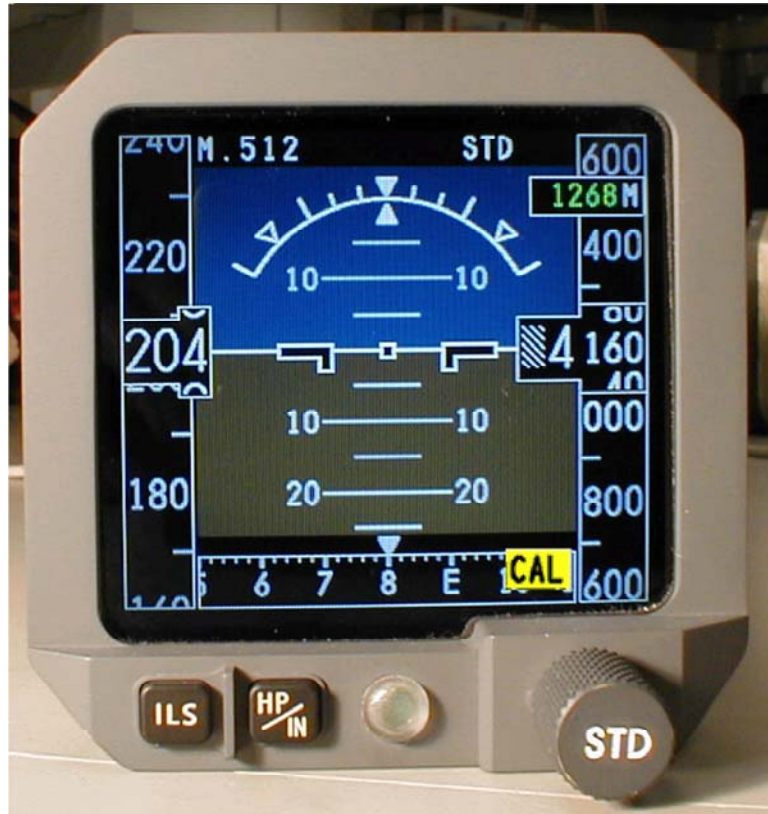
SFD in Calibration Mode

During calibration the MHS will transmit data on its heading from North and will shift/move the heading by 105 degrees momentarily every second to show that it is in calibration mode. The MHS will also transmit the data with bit 11 of the ARINC 429 data word set to show that it is in calibration mode. This BIT causes the SFD to Display the yellow 'CAL' flag on the display.

When calibration is completed successfully the MHS transmits normal calibrated heading data with the ARINC transmission status set to Normal Data (SSM = 0 0) to show that the calibration has been successful.
